# AAR-78-2

1. Report No. <b>NTSB-AAR-78-2</b>		2. Government Accession No.		3. Recipient's Catalog No.	
4. Title and Subtitle <b>Aircraft Accident Report - Allegheny Airlines, Inc., Douglas DC-9, N994VJ Philadelphia, Pennsylvania, June 23, 1976</b>		5. Report Date <b>January 19, 1978</b>		6. Performing Organization Code

AIRCRAFT ACCIDENT REPORT

ALLEGHENY AIRLINES, INC.  
DOUGLAS DC-9, N994VJ  
PHILADELPHIA INTERNATIONAL AIRPORT  
PHILADELPHIA, PENNSYLVANIA  
JUNE 23, 1976

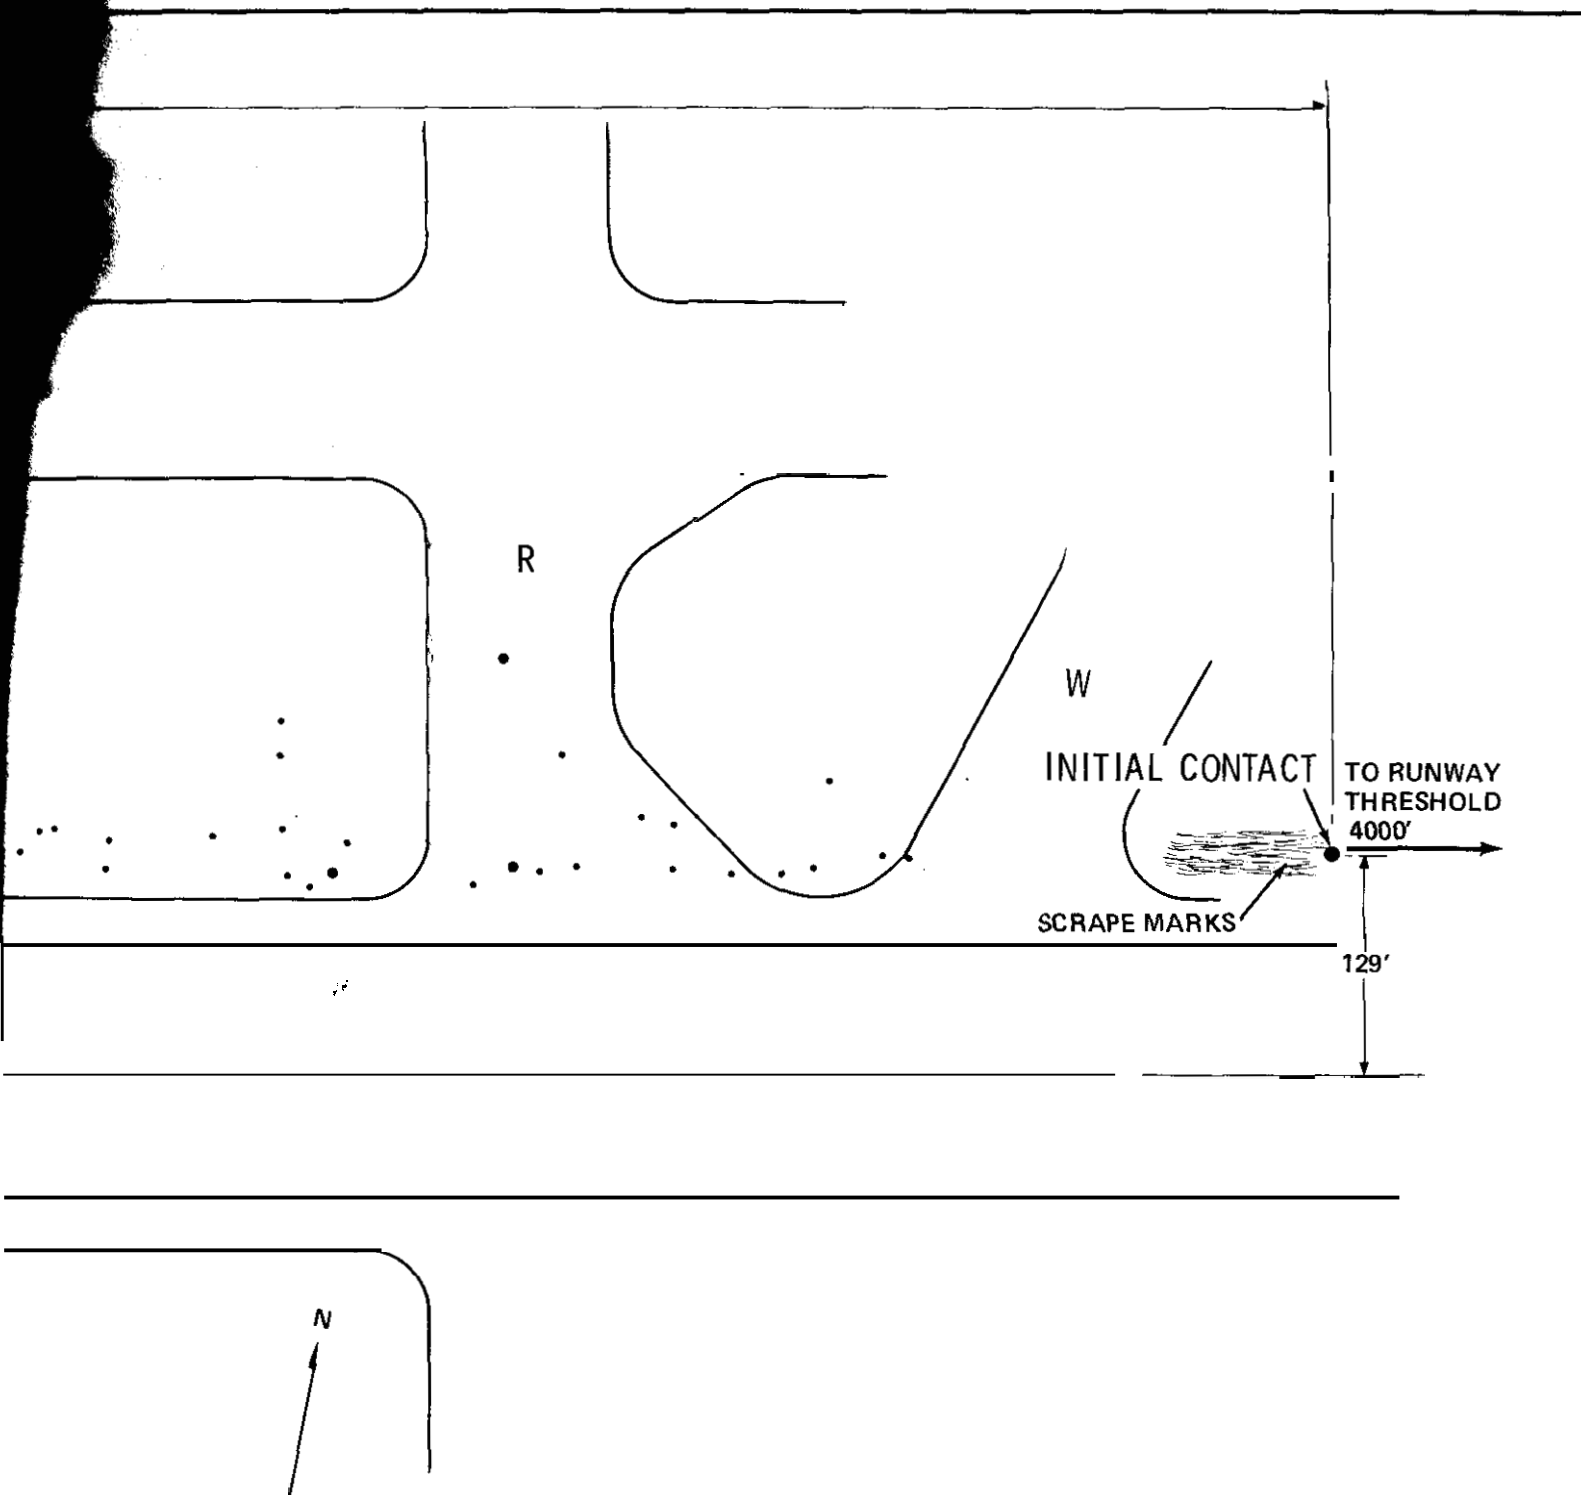
WRECKAGE DISTRIBUTION CHART  
ALLEGHENY AIRLINES, INC. DOUGLAS DC-9-30-N994VJ  
PHILADELPHIA INTERNATIONAL AIRPORT, PENNSYLVANIA  
23 JUNE 1976

The empennage and aft fuselage section had separated from the rest of the fuselage at a point just aft of the pressure bulkhead. The major portion of the fuselage, including the entire cabin and cockpit, was intact with both wings attached. The fuselage was damaged severely below the cusp line, at the rear pressure bulkhead, and at the engine stub wing-to-fuselage attachments. The fuselage lower nose structure was damaged. The lower skin of the fuselage was torn and abraded, the adjacent frames were crushed, and the stringers were damaged for the entire length of the aircraft. The cabin floor was buckled upward above the main landing gears (fuselage stations 699 to 756).

The basic wing structures were intact, but the left wing was damaged more heavily. There were no fuel leaks from the wing tanks. The empennage was attached to the aft fuselage section which had separated from the aircraft. The stabilizer was positioned for 9.8° noseup trim. The landing gear was fully retracted, the leading edge slats were fully extended, and the flaps were partially extended. Measurements taken of the flap extension mechanism revealed that the flaps were in the 15" position.

Both engines and their respective pylon stub wings had separated from the aircraft fuselage and were found 200 ft apart. The engines and the tail section were found between taxiway C and the main wreckage.
